Re: Roxborough Village - Liverpool And Cavaletti Park Safety Survey

Report Summary

Report Name: Roxborough Village - Liverpool And Cavaletti Park
Completed for: Roxborough Village Metro
Inspection Date: April 13, 2022
Score: 64.7%

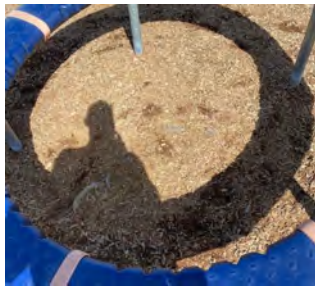
Issue Identified Loose-fill surfacing materials were displaced under heavy use areas
Recommendation Replace the surfacing material. [reference ASTM I 1487, CPSC] [View ASTM Site](#)

Notes: Surface material has been pushed around so much that the bottom material is coming up

Severity: Low (minor impact)

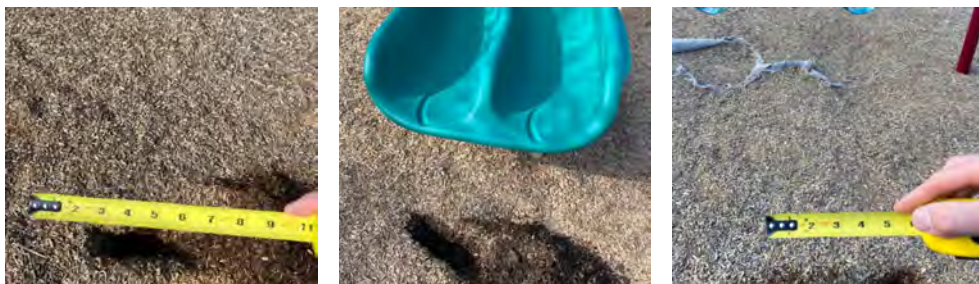
Issue Identified There is not 9 inches of surface material
Recommendation Ensure that there is minimum of 9 inches of surface material. It is recommended that you add enough material to have 12 inches of material so that there is 9 inches after compaction and after material is pushed around. [ASTM F1292] [View ASTM Site](#)

Notes: There is not enough surface material at the playground.

Severity: Moderate (marginal impact)
