**Colorado Special Districts
Property and Liability Pool**

Re: Roxborough - Mule Deer Park Safety Survey

Report Name: Roxborough - Mule Deer Park
Completed for: Roxborough Village Metro
Inspection Date: March 15, 2022
Score: 52.6%

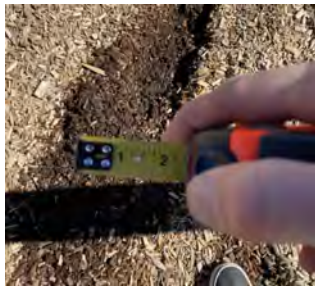
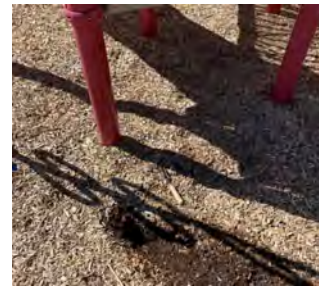
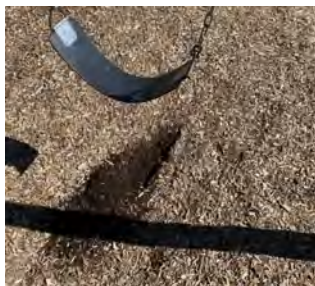
Issue Identified Loose-fill surfacing materials were displaced under heavy use areas

Notes: There appears to be enough surface material around the playground. It has just been displaced and needs more raking of the material into heavily trafficked areas.

Severity: Advisory (negligible impact)

Recommendation Replace the surfacing material. [reference ASTM I 1487, CPSC] [View ASTM Site](#)

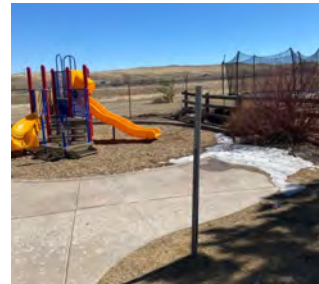
Issue Identified **The signs used for play areas are not legible or are not in good repair**

Notes: Sign is missing completely. Replace the sign.

Severity: Advisory (negligible impact)

Recommendation *Maintain the signs in the park so they are legible and in good repair. [reference ASTM 1487, CPSC] [View ASTM Site](#)*

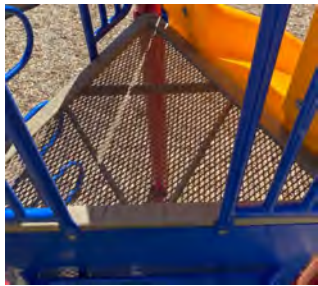
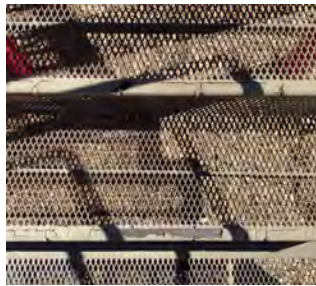
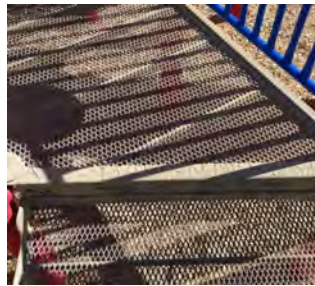
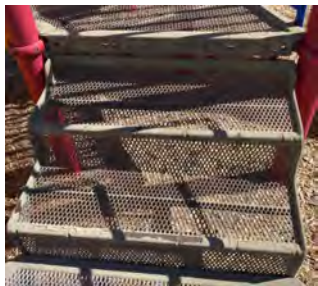
Issue Identified **There are broken or cracked pieces on the equipment**

Notes: The entire structure has cracking and breaking surface material. The playground is showing its age. At this point I think that the playground walking areas are beyond re-coating and it is time to start thinking about replacing the structure.

Severity: Moderate (marginal impact)

Recommendation *Repair and or replace broken or cracked pieces on the equipment. [reference ASTM 1487, CPSC] [View ASTM Site](#)*

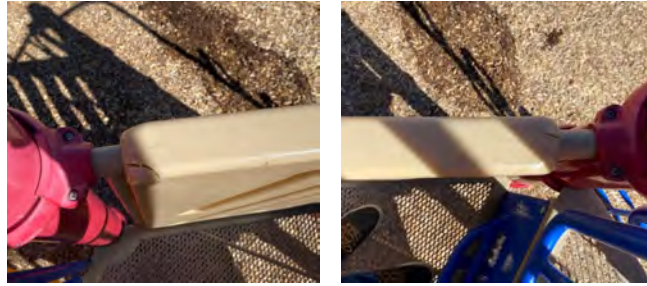
Issue Identified **There are broken or cracked pieces on the equipment**

Notes: The panel is cracked on both ends and needs to be replaced. This is one more reason that the playground needs to be replaced in the very near future.

Severity: Moderate (marginal impact)

Recommendation *Repair and or replace broken or cracked pieces on the equipment. [reference ASTM 1487, CPSC] [View ASTM Site](#)*

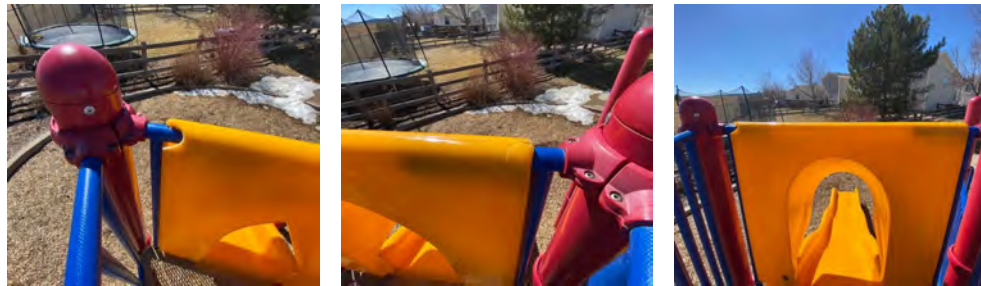
Issue Identified **There are broken or cracked pieces on the equipment**

Notes: The top of the slide is cracked and needs to be replaced. Reason number 3 on why the playground needs to be replaced. At this point it may cost more to fix everything than it would be to replace the playground.
Severity: Moderate (marginal impact)
Contributing Factor: Equipment

Recommendation *Repair and or replace broken or cracked pieces on the equipment. [reference ASTM 1487, CPSC] [View ASTM Site](#)*
