**Colorado Special Districts
Property and Liability Pool**

Re: Roxborough - Crystal Lake Park Safety Survey

Report Name: Roxborough - Crystal Lake Park
Completed for: Roxborough Village Metro
Inspection Date: March 15, 2022
Score: 26.9%

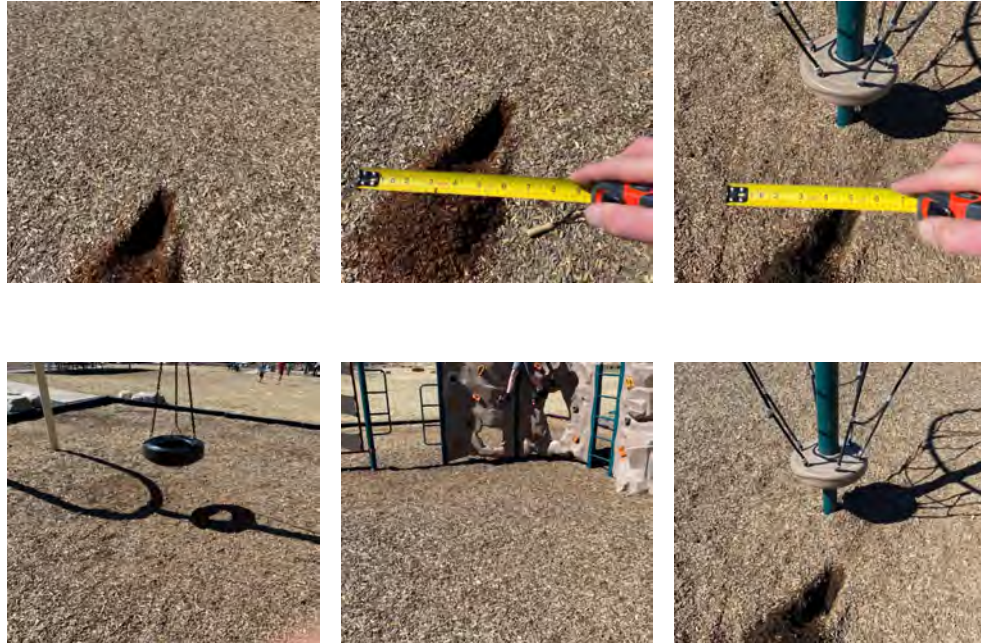
Issue Identified **There is not 9 inches of surface material**
Recommendation *Ensure that there is minimum of 9 inches of surface material. It is recommended that you add enough material to have 12 inches of material so that there is 9 inches after compaction and after material is pushed around. [ASTM F1292] [View ASTM Site](#)*

Notes: There is not quite enough material in this area. There needs to be at least 9 inches of material. Because you do not have someone maintaining the playground weekly you should put a total of 12 inches of material in all areas.

Severity: Moderate (marginal impact)

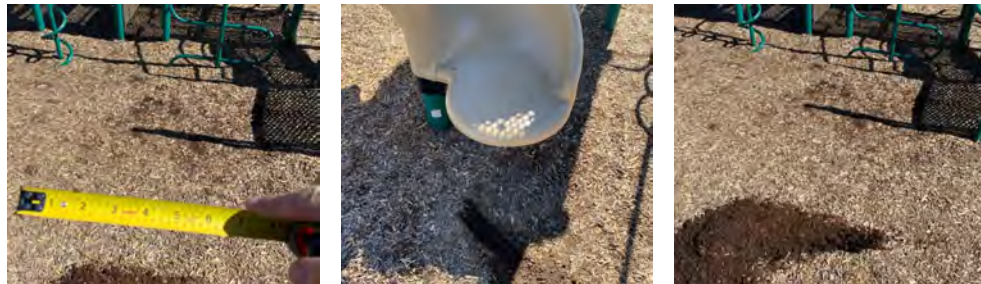
Issue Identified **There is not 9 inches of surface material**

Notes: More surface material needs to be added to the main playground. Ensure there is a total of 12 inches of material to allow for displacement and compaction.

Severity: Moderate (marginal impact)

Recommendation *Ensure that there is minimum of 9 inches of surface material. It is recommended that you add enough material to have 12 inches of material so that there is 9 inches after compaction and after material is pushed around. [ASTM F1292] [View ASTM Site](#)*

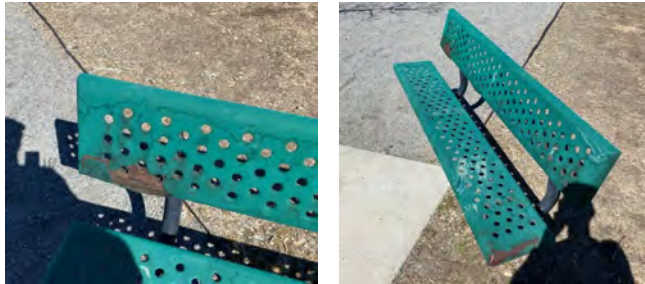
Issue Identified **There are damaged fences, benches, or signs on the playground**

Notes: The benches have seen better days. Start thinking about re-coating the benches so they stay in good condition.

Severity: Advisory (negligible impact)

Recommendation *Repair/replace damaged fences, benches, or signs on the playground. [reference ASTM 1487, CPSC] [View ASTM Site](#)*

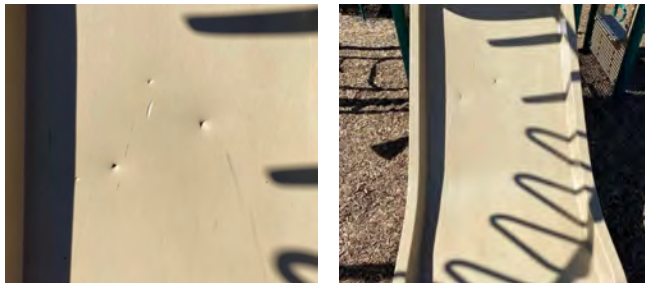
Issue Identified **Evidence of vandalism present**

Notes: The slide looks like it was stabbed with something. Monitor it to make sure it does not get worse.

Severity: Advisory (negligible impact)

Recommendation *Mitigate all evidence of vandalism. [reference ASTM 1487, CPSC] [View ASTM Site](#)*

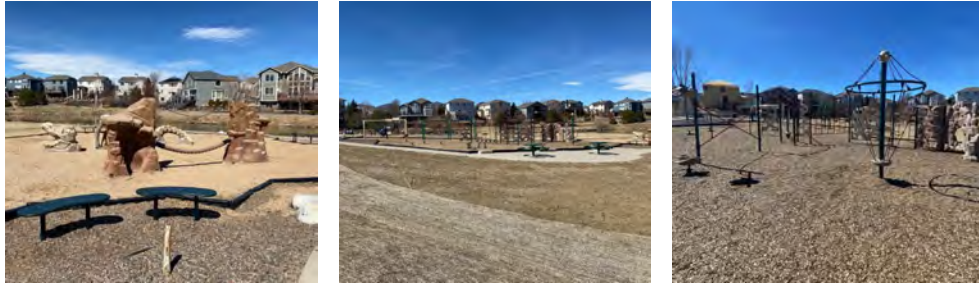
Issue Identified **The signs used for play areas are not legible or are not in good repair**

Notes: The playground is missing signage with rules and age ranges for the different structures.

Severity: Low (minor impact)

Recommendation *Maintain the signs in the park so they are legible and in good repair. [reference ASTM 1487, CPSC] [View ASTM Site](#)*

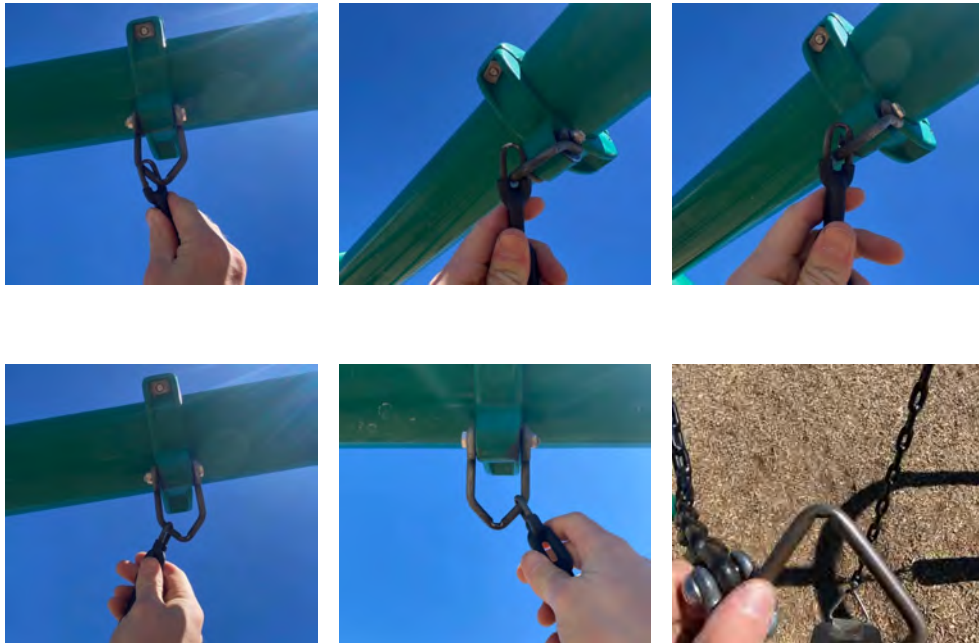
Issue Identified The swing chains are not in good condition

Notes: The swing set chains and brackets are all in VERY poor condition and need to be replaced. 10% of wear is allowed and these swings are more on the 50% of wear. It is only a matter of time before the break.

Severity: Serious/Extreme (deducts 5%)

Recommendation Replace or repair the swing chains. [reference ASTM 1487, CPSC] [View ASTM Site](#)

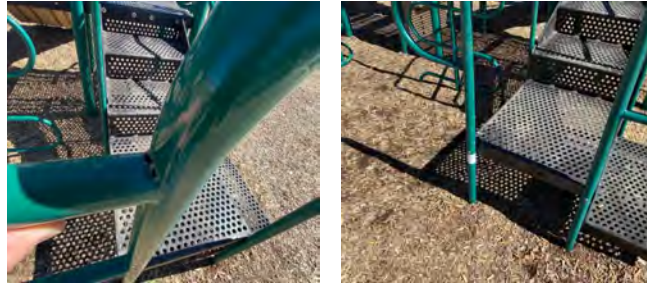
- Issue Identified** **There are broken or cracked pieces on the equipment**
- Recommendation** *Repair and or replace broken or cracked pieces on the equipment. [reference ASTM 1487, CPSC] [View ASTM Site](#)*

Notes: This handrail has an incomplete weld. This allows water to go inside and it can damage the playground from the inside out. I would try to get it replaced by the manufacturer.

Severity: Low (minor impact)
 Contributing Factor: Equipment

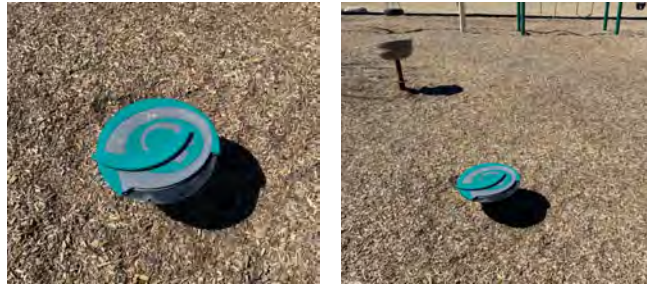
Issue Identified There are broken or cracked pieces on the equipment

Notes: The spinner is broken on the top and needs to be replaced.
Severity: Low (minor impact)
Contributing Factor: Equipment

Recommendation Repair and or replace broken or cracked pieces on the equipment. [reference ASTM 1487, CPSC] [View ASTM Site](#)

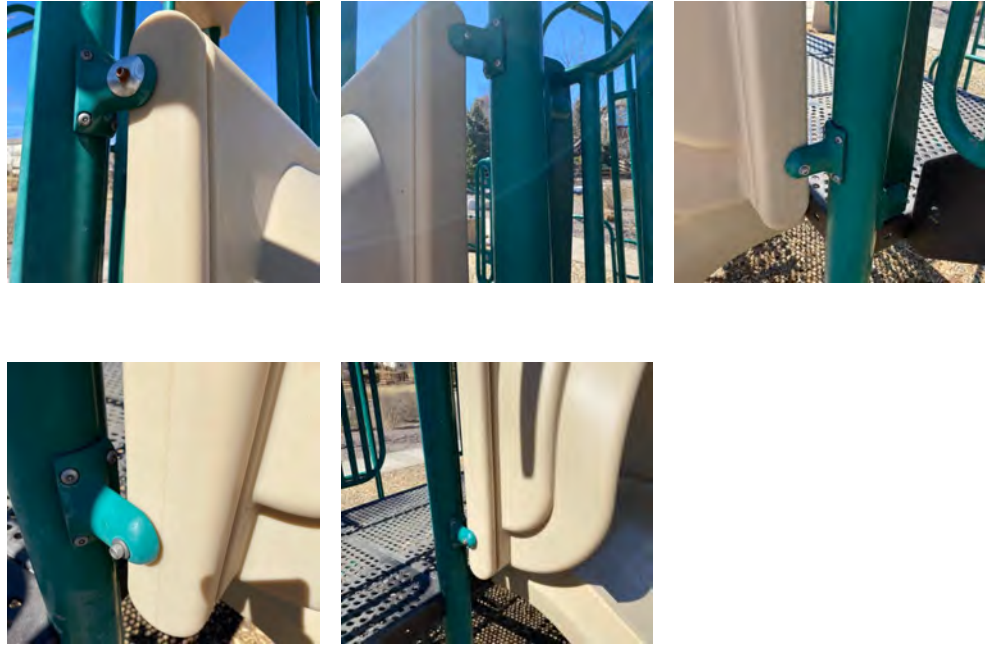
Issue Identified There are protrusions on the structure

Notes: Replace the bolts with the proper bolts. Proper screw/bolt is in the last picture.
Severity: Advisory (negligible impact)
Contributing Factor: Equipment

Recommendation There are no protrusions on the structure (No more than two threads protruding). [reference ASTM 1487, CPSC] [View ASTM Site](#)

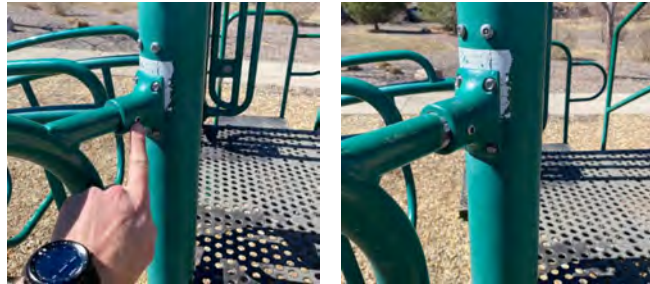
Issue Identified **There are loose, missing bolts or nuts on the equipment**

Notes: Lose screw on the main play structure.
Severity: Low (minor impact)
Contributing Factor: Equipment

Recommendation *Replace and or tighten the nuts in accordance with manufactures instructions. [reference ASTM I 1487, CPSC] [View ASTM Site](#)*

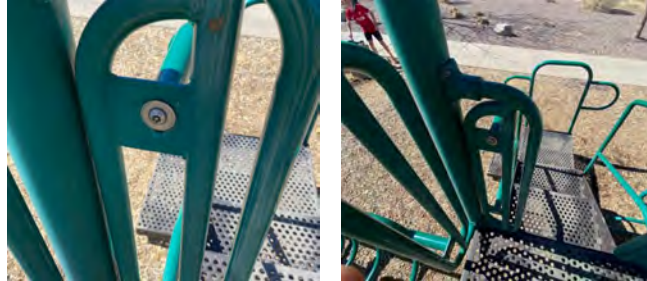
Issue Identified There are loose, missing bolts or nuts on the equipment

Notes: Lose bolt
Severity: Advisory (negligible impact)
Contributing Factor: Equipment

Recommendation *Replace and or tighten the nuts in accordance with manufactures instructions. [reference ASTM 1487, CPSC] [View ASTM Site](#)*

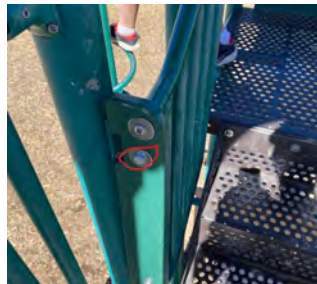
Issue Identified **There are loose, missing bolts or nuts on the equipment**

Notes: Replace bolt with the proper bolt and not something from the hardware store.
Severity: Advisory (negligible impact)
Contributing Factor: Equipment

Recommendation *Replace and or tighten the nuts in accordance with manufactures instructions. [reference ASTM 1487, CPSC] [View ASTM Site](#)*
