Re: Roxborough - Marmot Ridge Park Safety Survey

Report Summary

Report Name: Roxborough - Marmot Ridge Park
Completed for: Roxborough Village Metro
Inspection Date: March 15, 2022
Score: 66.7%

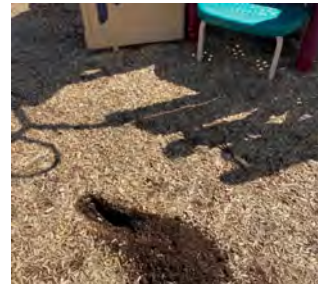
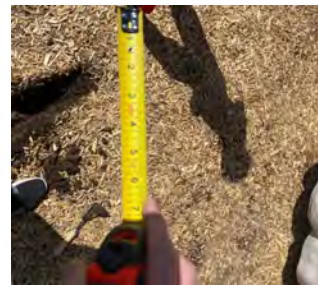
Photo(s)

Issue Identified There is not 9 inches of surface material

Notes: There is not enough surface material. Make sure there is a total of 12 inches so that you can maintain at least 9 inches in all areas.

Severity: Moderate (marginal impact)

Recommendation Ensure that there is minimum of 9 inches of surface material. It is recommended that you add enough material to have 12 inches of material so that there is 9 inches after compaction and after material is pushed around. [ASTM F1292] [View ASTM Site](#)

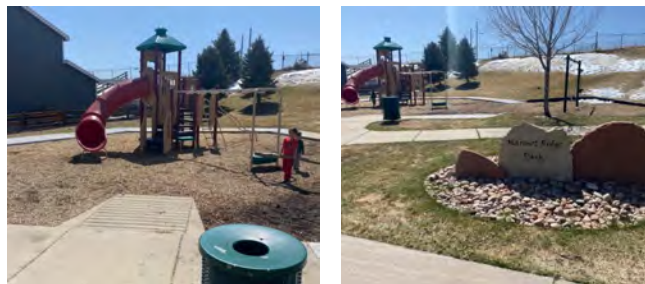
Photo(s)

The signs used for play areas are not legible or are not in good repair

Notes: There is no playground signage for the park

Severity: Low (minor impact)

Maintain the signs in the park so they are legible and in good repair. [reference ASTM I 1487, CPSC] [View ASTM Site](#)

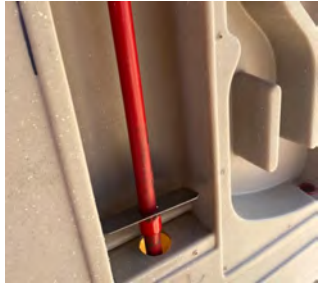
Photo(s)

There are broken or cracked pieces on the equipment

Notes: The back of the panel is broken. I am not sure what it looked like before. It appears that it may have been plexiglass.

Severity: Advisory (negligible impact)

Repair and or replace broken or cracked pieces on the equipment. [reference ASTM I 1487, CPSC] [View ASTM Site](#)

At a minimum I would remove the metal piece.
